***Critical Area Report and Wetland Mitigation and Bank Use Plan
Olteanu Property***

***Parcels# 042405-9110, 042405-9111, and 042405-9112
Bellevue, Washington***

This Critical Area Report and Mitigation Plan have been prepared for a proposed single-family residence in the City of Bellevue. The intent of this report is to describe previously delineated wetlands on the undeveloped property and summarize their regulatory constraints and requirements for development of the property in support of a Critical Area Land Use Permit (CALUP) from the City of Bellevue. The applicant proposes to build a single-family home and an entry road to access it from 128th Avenue SE, which will impact wetland and buffer. This report includes a mitigation plan, which will identify compensatory actions for wetland and buffer impacts. Consultant qualifications are included in **Appendix A**.

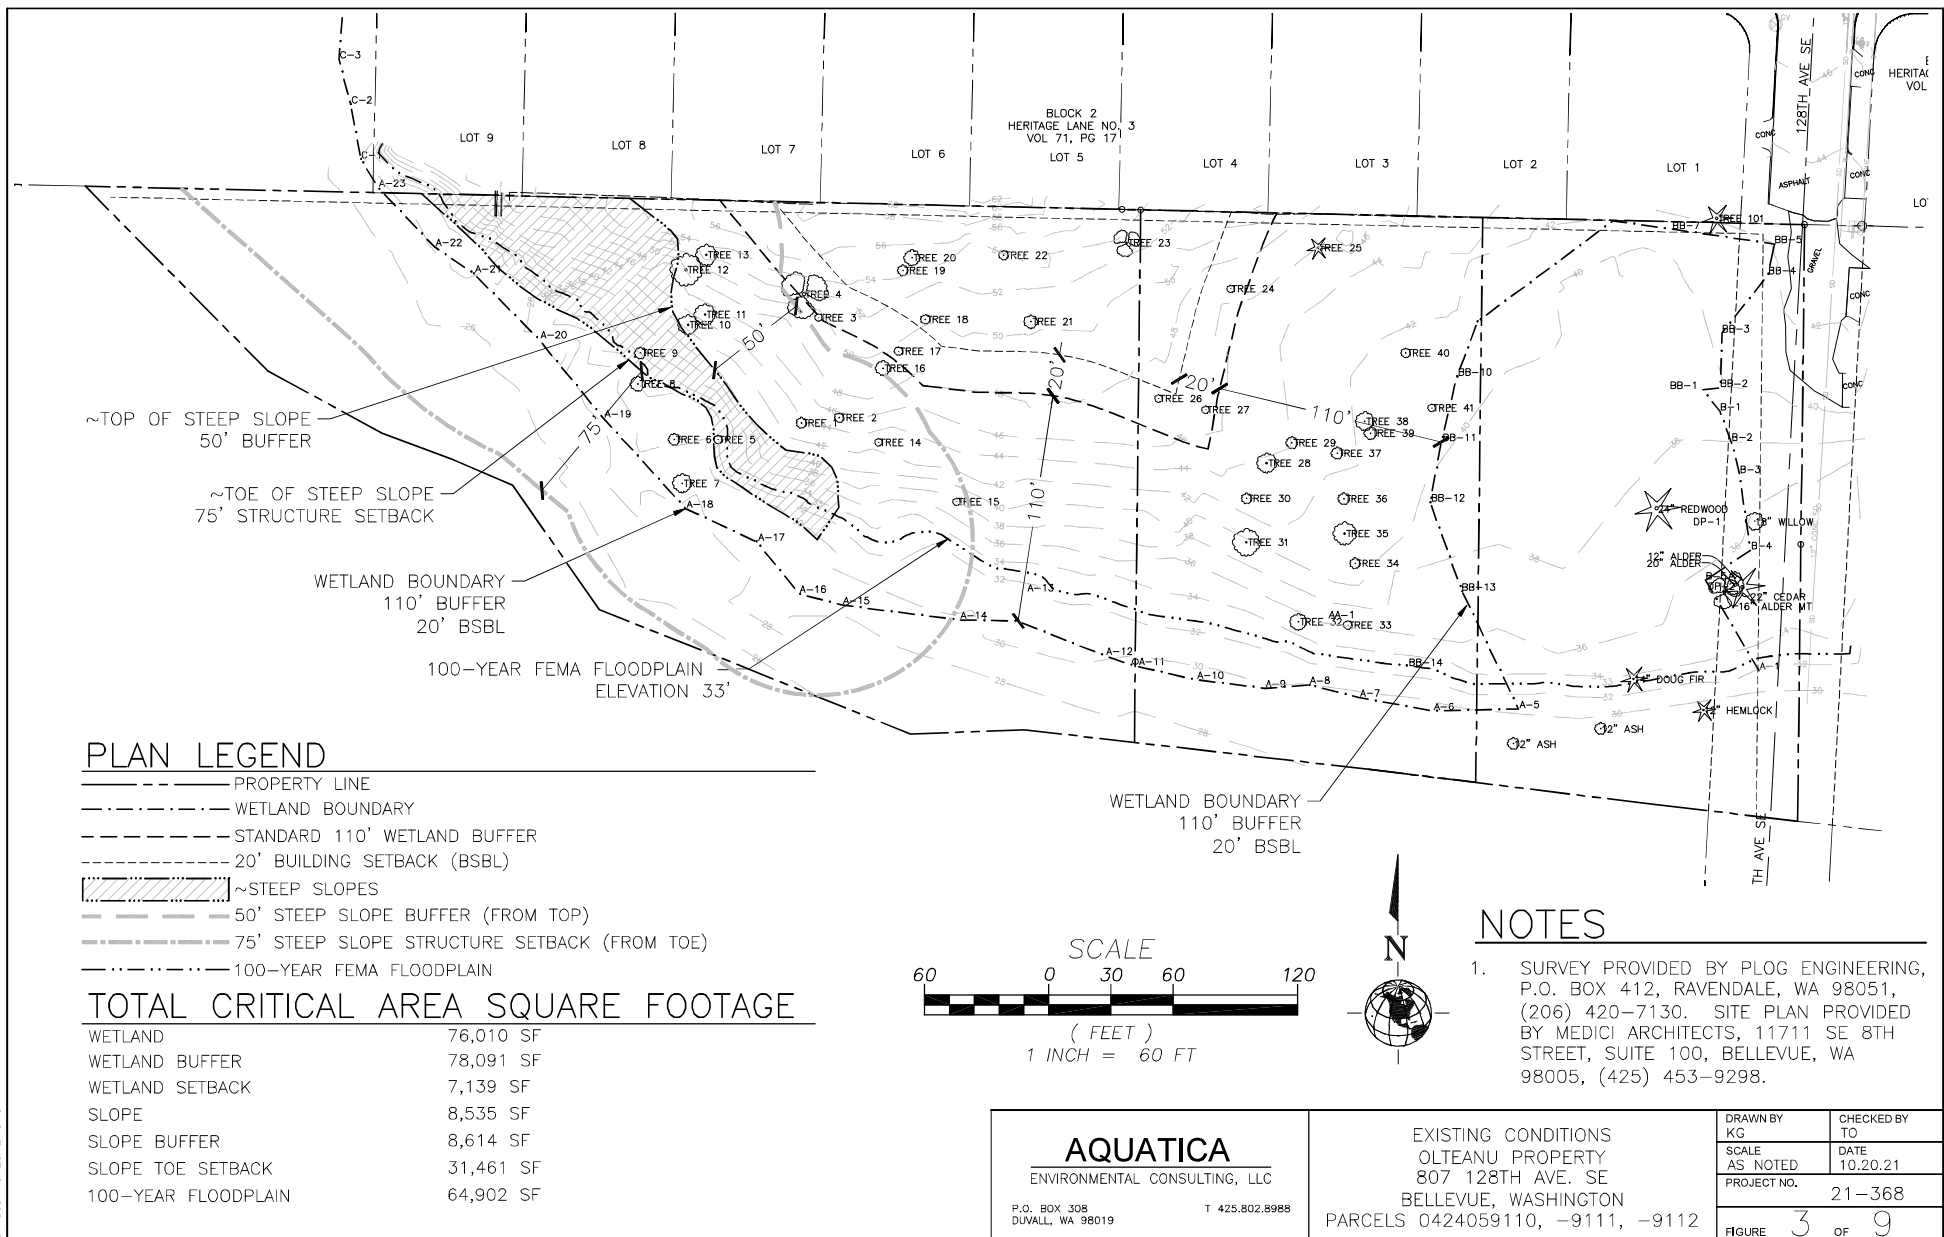
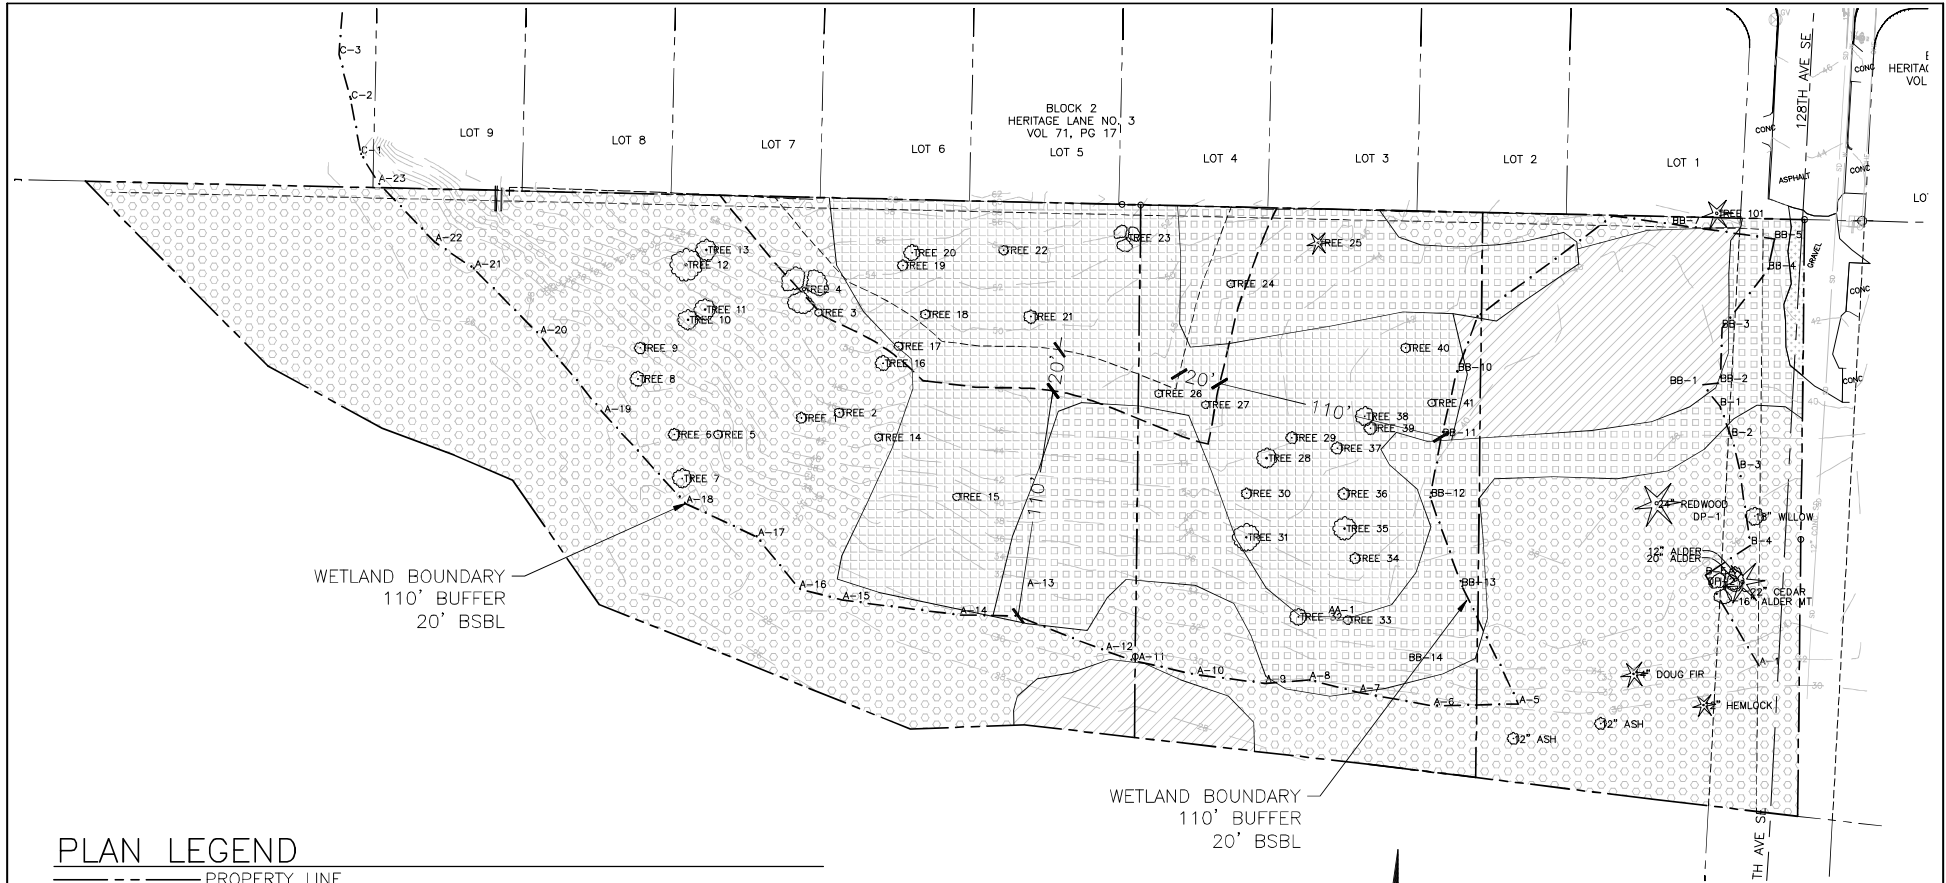
AQUATICA ENVIRONMENTAL CONSULTING, LLC P.O. BOX 308 DUVALL, WA 98019	T 425.802.8988	EXISTING VEGETATION OLTEANU PROPERTY 807 128TH AVE. SE BELLEVUE, WASHINGTON PARCELS 0424059110, -9111, -9112		DRAWN BY KG	CHECKED BY TO
				SCALE AS NOTED	DATE 10.20.21
				PROJECT NO. 21-368	
				FIGURE 4	OF 9

- PROPERTY LINE
- WETLAND BOUNDARY
- STANDARD 110' WETLAND BUFFER
- 20' BUILDING SETBACK (BSBL)
- [Pattern] NATIVE VEGETATION - 93,204 SF
- [Pattern] REED CANARYGRASS - 13,326 SF
- [Pattern] SCATTERED TREES WITH BLACKBERRIES AND FERNS IN THE GROUNDCOVER LAYER - 36,272 SF
- [Pattern] DENSE BLACKBERRIES - 30,387 SF
- [Pattern] GRAVEL - 558 SF

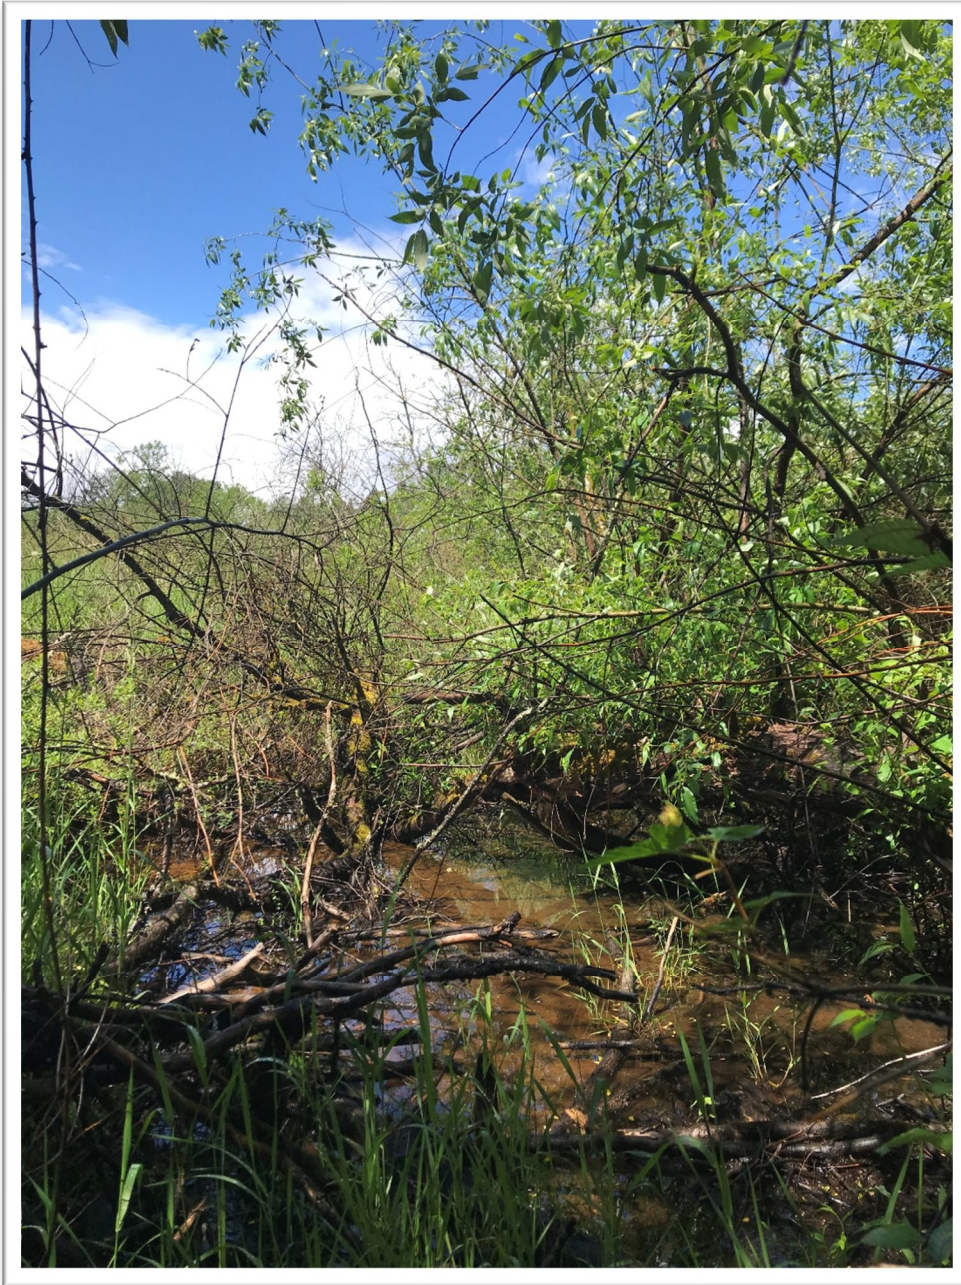
Photo 1. Wetland A to the south of the project area (no disturbance planned in this area)

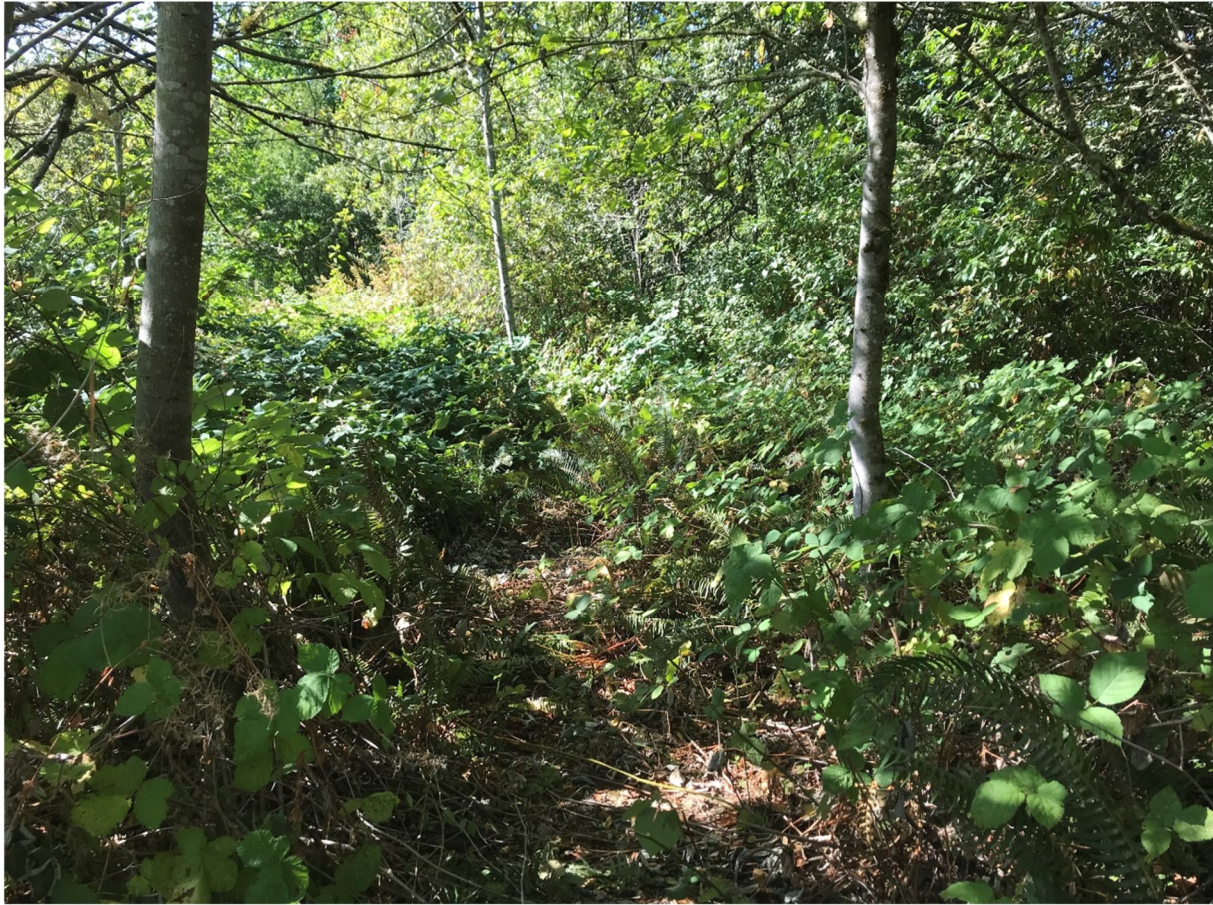
Photo 2. Wetland A buffer with Armenian blackberry in the understory

Armenian blackberry is present throughout most of the eastern two-thirds of on-site buffer areas. In designated enhancement areas, these will be cut down, and the roots grubbed out. All parts of the plants

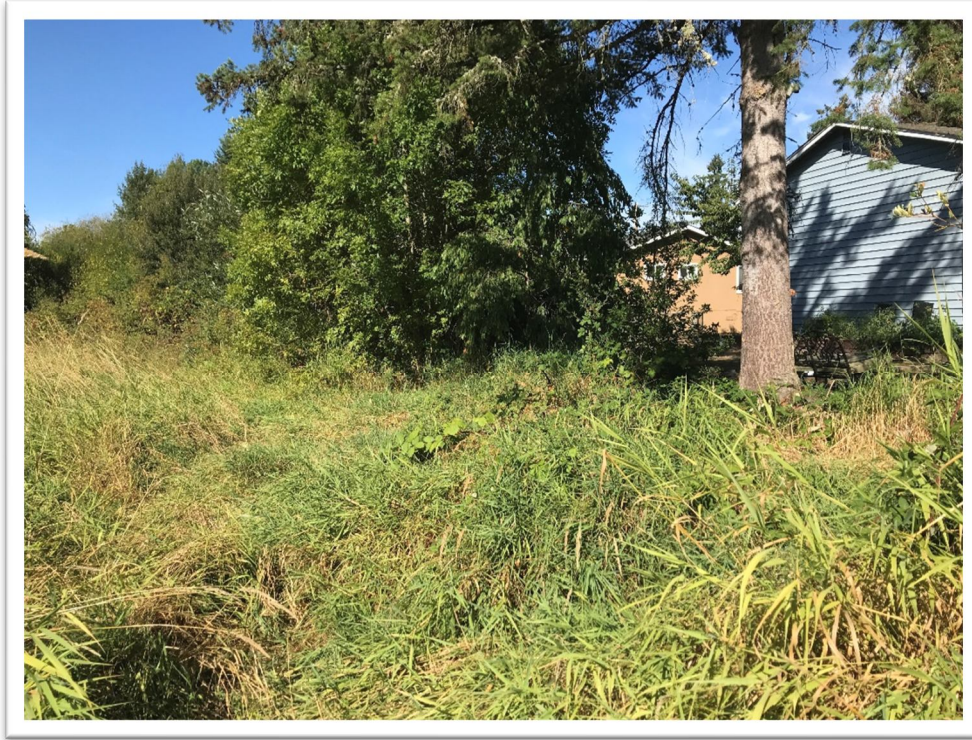
Photo 3. Photo of proposed driveway location through the reed canarygrass dominated portion of Wetland A, taken from 128th Avenue NE, looking to the northwest

through the City parcel would also disturb steep slopes and the native buffer vegetation in the western third of the site. See Photos 3 and 4, respectively the proposed driveway location from 128th Avenue NE and the northeastern edge of the City-owned parcel.

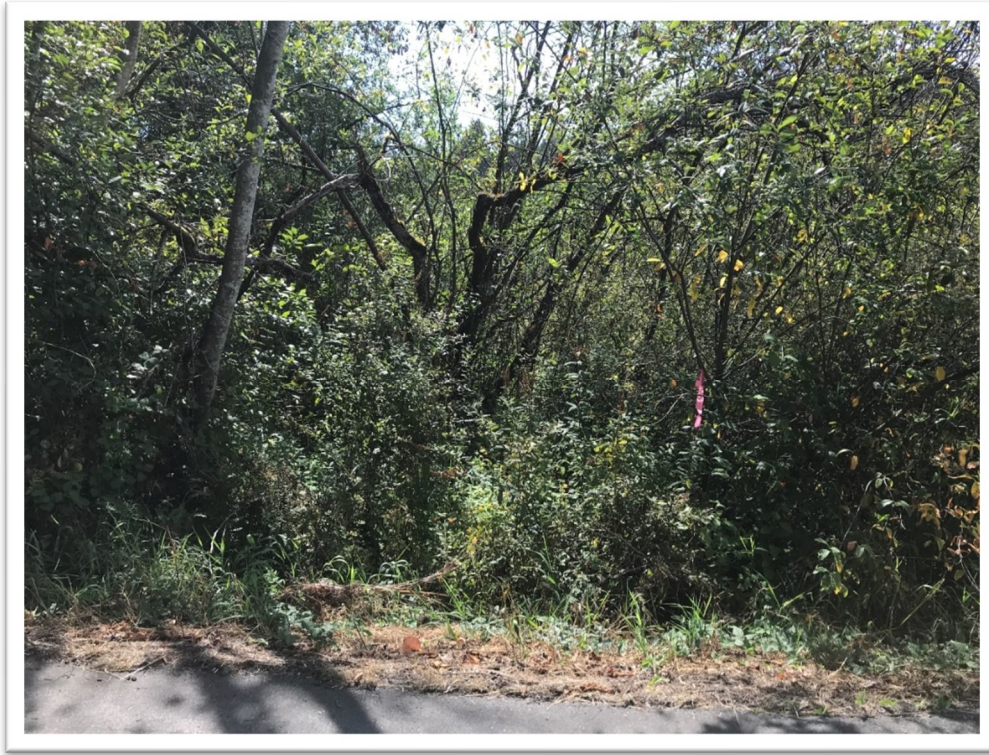
Photo 4. Forested wetland area investigated for potential access from SE 7th Place. Photo taken from SE 7th Place looking to the south at Wetland A

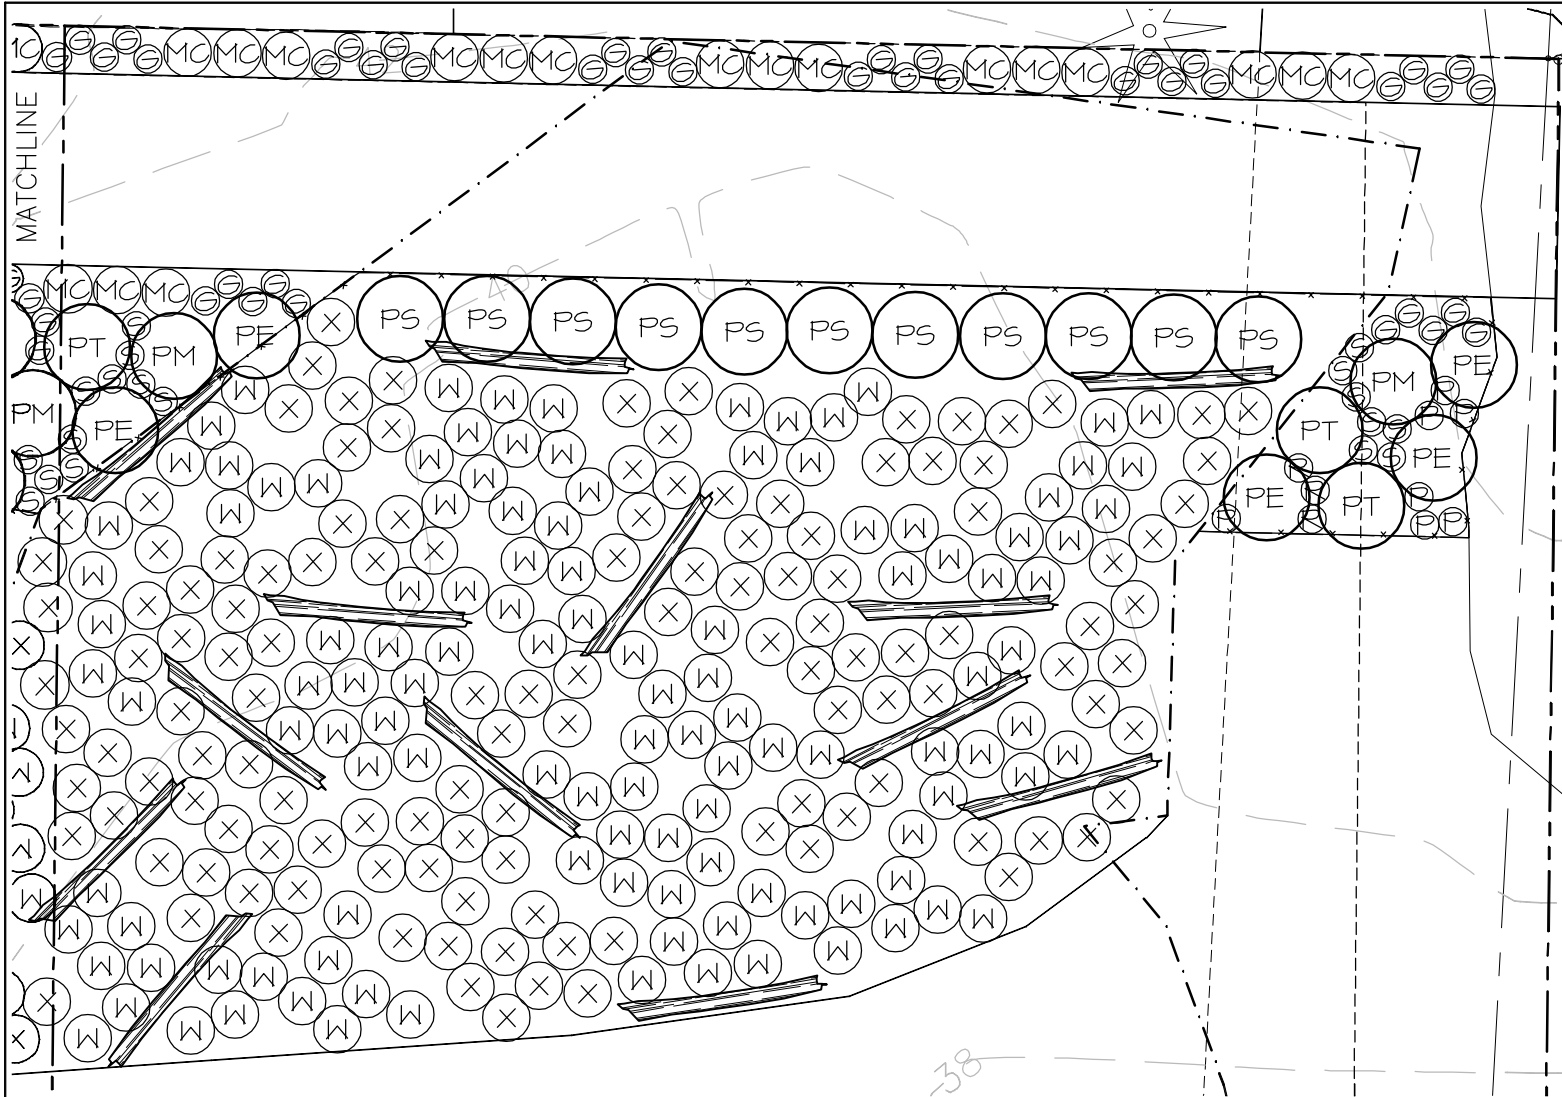
KEY	SCIENTIFIC NAME	COMMON NAME	SIZE (MIN.)	SPACING	QUANTITY
G	GAULTHERIA SHALLON	SALAL	1 GAL.	3' O.C.	159
P	POLYSTICHUM MUNITUM	SWORD FERN	1 GAL.	3' O.C.	54
